**Flood Control Project Maintenance  
Levee Inspections**

**Fall 2010 Levee Maintenance Deficiency Summary Report**

**Reclamation District No. 0307 Lisbon**

**Levee Inspection Report By Mile - Fall 2010**

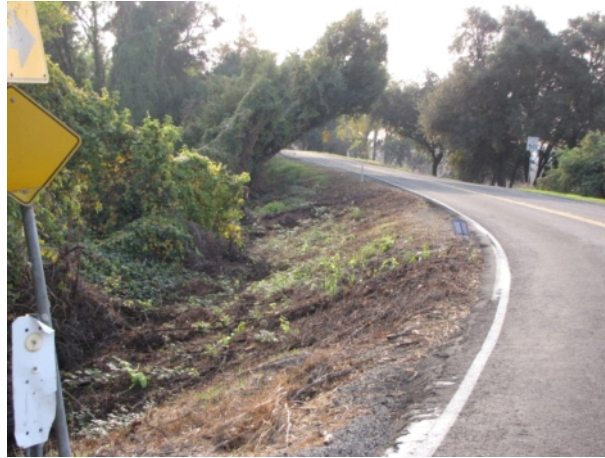
Levee Mile Report Line	2
Start Levee Mile	0.01
End Levee Mile	0.01
Location	Water Side
Category	Earthen Levee
Item	Vegetation
RD 307 Levee mile 0.00 water side looking downstream. Photo taken 11-05-2010	
phillips_f_20101130_358.jpg

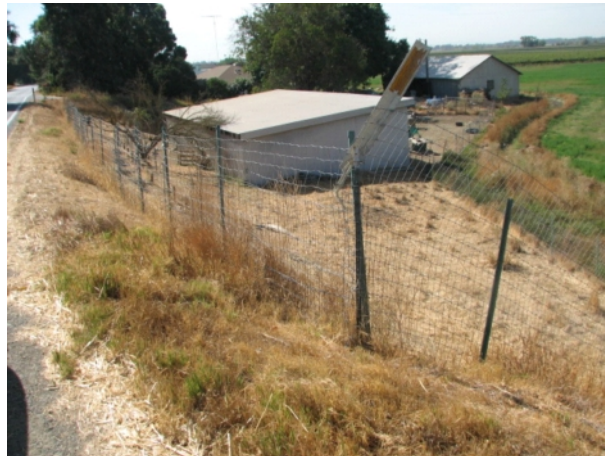
Levee Mile Report Line	22
Start Levee Mile	2.99
End Levee Mile	3.03
Location	Land Side
Category	Earthen Levee
Item	Encroachments
unauthorized fence located landward in RD 307.	
phillips_f_20100923_159.jpg

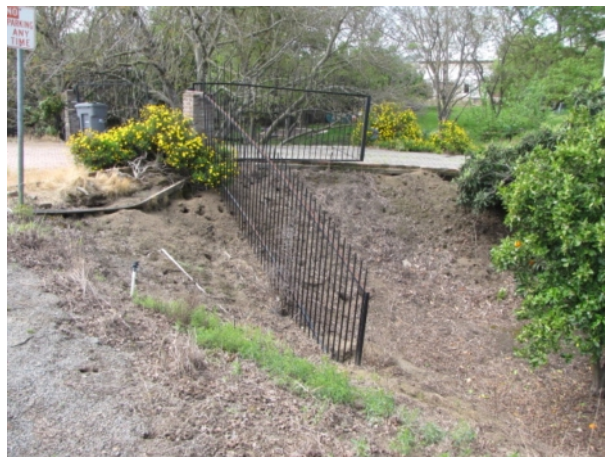
Levee Mile Report Line	28
Start Levee Mile	3.54
End Levee Mile	3.56
Location	Land Side
Category	Earthen Levee
Item	Animal Control
This photo shows Rodent holes in slope and within ramp. There actually is a rodent in view by the iron fence just about 3-foot from the bottom of the fence line.	
phillips_f_20100923_157.jpg

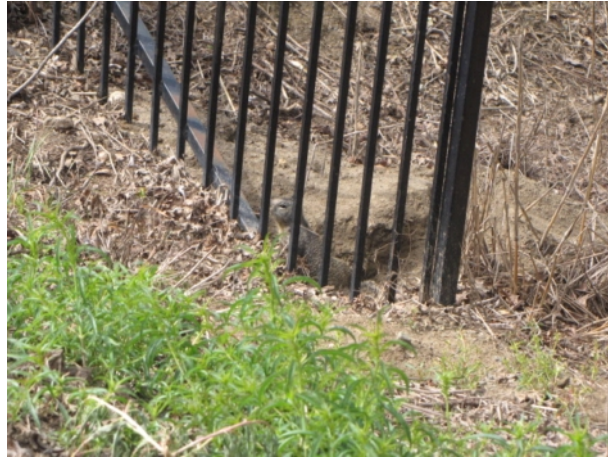
Levee Mile Report Line	28
Start Levee Mile	3.54
End Levee Mile	3.56
Location	Land Side
Category	Earthen Levee
Item	Animal Control

Photo shows live rodent near fence out side of his burrow.

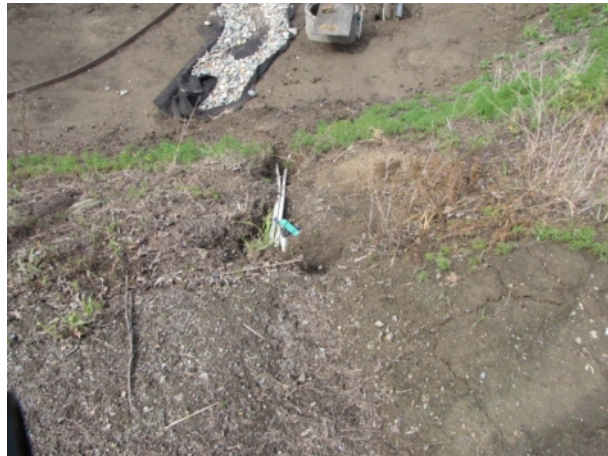
Levee Mile Report Line	29
Start Levee Mile	3.54
End Levee Mile	3.56
Location	Land Side
Category	Earthen Levee
Item	Encroachments

Photo shows pvc pipe placed in levee slope. 4 sprinklers are placed in slope.

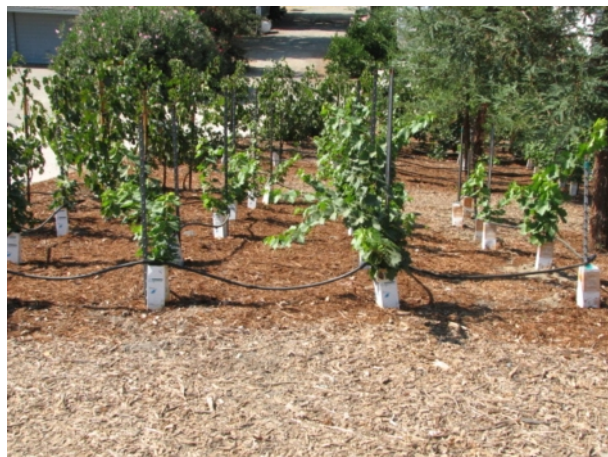
Levee Mile Report Line	43
Start Levee Mile	4.43
End Levee Mile	4.44
Location	Land Side
Category	Earthen Levee
Item	Encroachments

Unauthorized grape vines with driplines placed within levee shoulder and slope, levee miles 4.43 to 4.44 38.443798 121.50332 and 38.44365086 - 121.50322 land side. There is no Permit for this Encroachment.

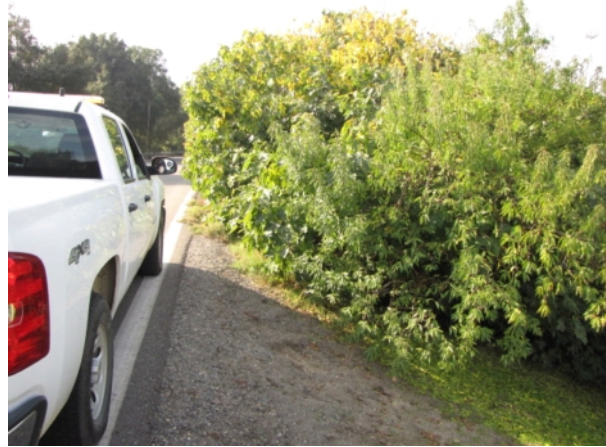
Levee Mile Report Line	46
Start Levee Mile	4.71
End Levee Mile	4.75
Location	Land Side
Category	Earthen Levee
Item	Vegetation

RD 307 landside view of unsatisfactory wild growth on levee section at levee miles 4.71 to 4.75. Photo taken 11-05-2010.

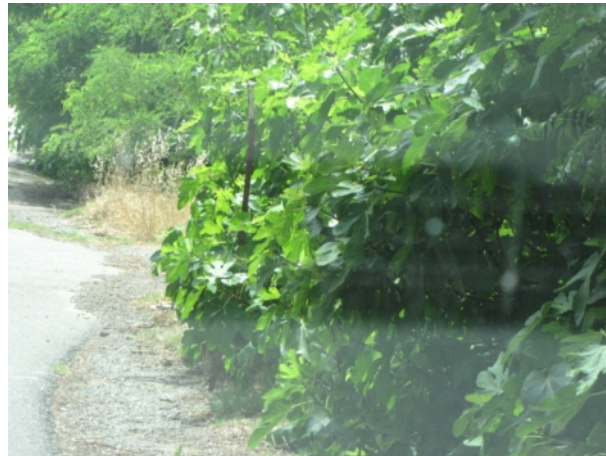
Levee Mile Report Line	49
Start Levee Mile	4.78
End Levee Mile	4.83
Location	Land Side
Category	Earthen Levee
Item	Trim / Thin Trees

Looking down stream from levee mile 4.78 the fig trees has covered the levee section on the land side. The wild growth continues down stream to 4.83. Photo taken 11-05-2010

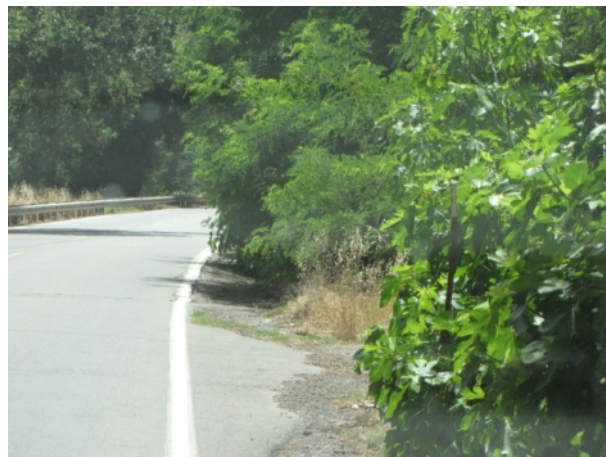
Levee Mile Report Line	49
Start Levee Mile	4.78
End Levee Mile	4.83
Location	Land Side
Category	Earthen Levee
Item	Trim / Thin Trees

Showing the wild growth continues downstream landside shoulder and slope, visibility completely blocked. Photo taken 11-05-2010

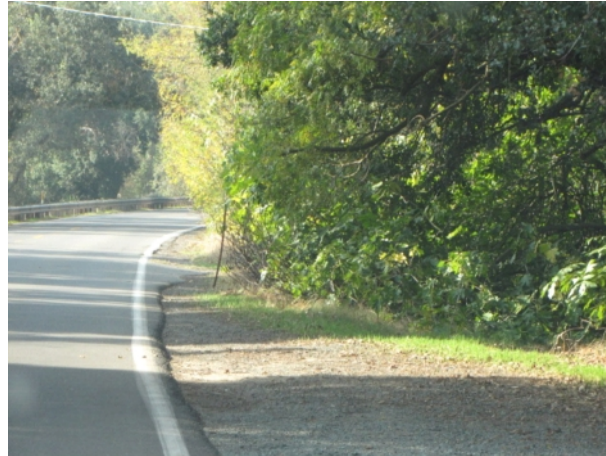
Levee Mile Report Line	50
Start Levee Mile	4.81
End Levee Mile	4.82
Location	Land Side
Category	Earthen Levee
Item	Vegetation
RD 307 levee mile 4.81 unsatisfactory growth on landside levee shoulder and slope. Photo taken 11-05-2010	
phillips_f_20101130_360.jpg

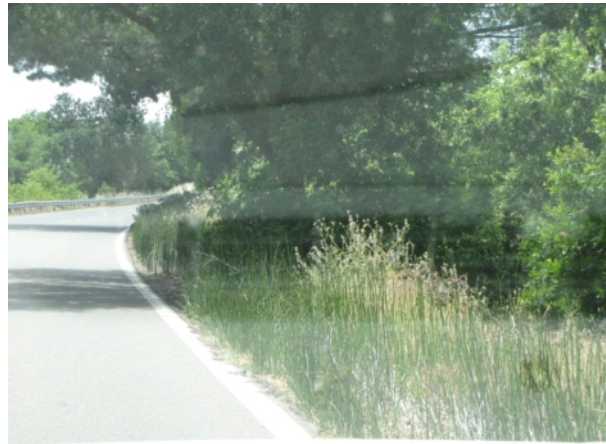
Levee Mile Report Line	56
Start Levee Mile	5.16
End Levee Mile	5.20
Location	Water Side
Category	Earthen Levee
Item	Vegetation
Wild growth on landside at leve mile 5.16 to 5.20 looking down stream.	
phillips_f_20100923_164.jpg

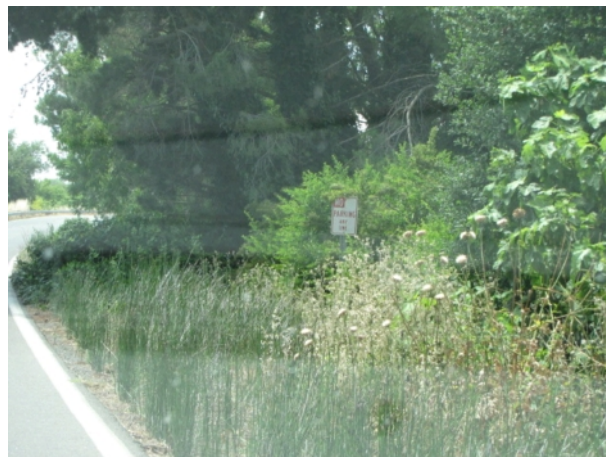
Levee Mile Report Line	56
Start Levee Mile	5.16
End Levee Mile	5.20
Location	Water Side
Category	Earthen Levee
Item	Vegetation
Looking downstream levee mile 5.16-5.20.	
phillips_f_20100923_165.jpg
